16.0 Shiprock, New Mexico, Disposal Site

16.1 Compliance Summary

The Shiprock, New Mexico, Disposal Site, inspected on August 15, 2007, is in excellent condition. Erosion along the southwest bank of the outflow channel requires repair. All other structures are in good condition. Research associated with cell performance that includes the collection of saturated hydraulic conductivity measurements, continued. DOE continues to study the effects of deep-rooted vegetation encroachment on the cell to evaluate the need for ongoing control. Scattered shrubs on the cell and in the outflow channel require additional treatment. Tumbleweeds and trash continue to accumulate along the perimeter fence and in the outflow channel area; removal is warranted in the outflow channel. No cause for a follow-up or contingency inspection was identified.

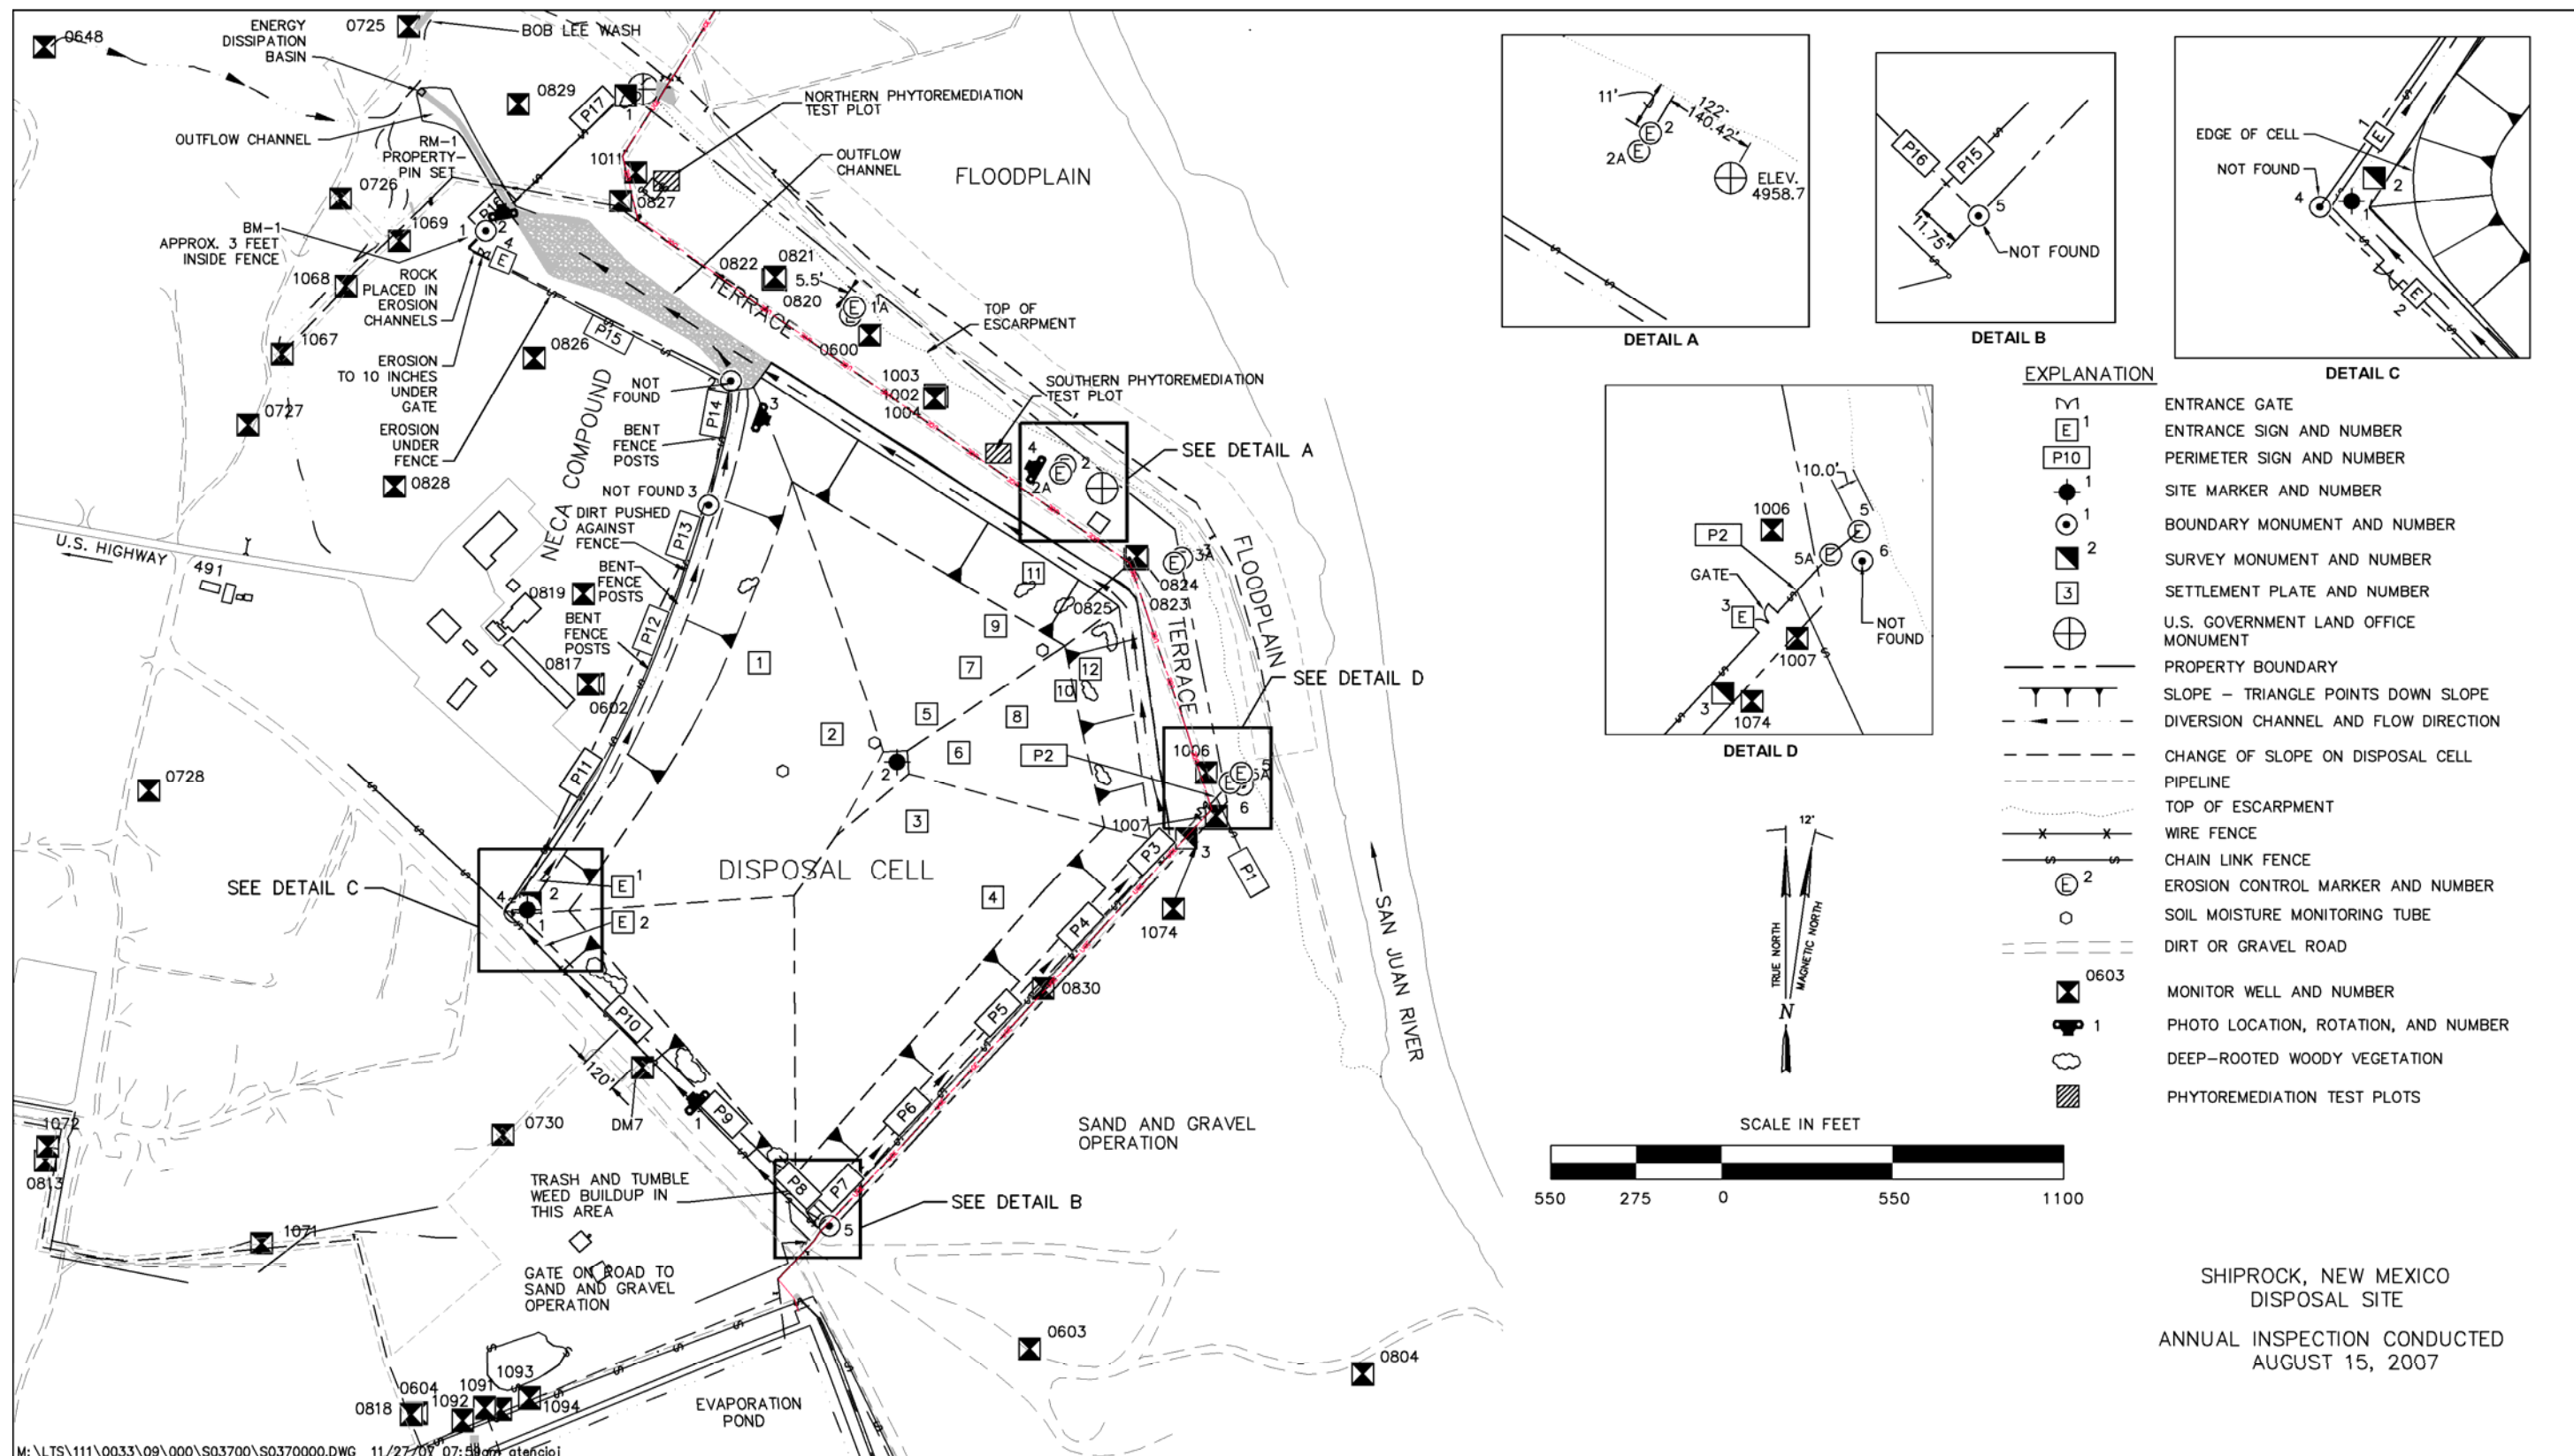
Figure 16-1. 2007 Annual Compliance Drawing for the Shiprock, New Mexico, Disposal Site

Woody vegetation in the outflow channel has been treated with herbicide in past years. The 2006 herbicide treatment was highly effective, with an estimated 95 percent kill (PL-3). Several patches of deep-rooted vegetation remain and are noted on Figure 16-1. Most of the vegetation on the cell is composed of shallow-rooted vegetation. Several noxious weeds were found and pulled by hand during the inspection.
